<b>Evolution of the Black Sea Shore in the Danube Delta Biosphere Reserve Area</b> <i>(Dănuț Diaconeasa, Silică Petrișoiaia, Gheorghe Munteanu, Răzvan Doru Mateescu, Alina Daiana Spînu)</i>	<b>“Cercetări Marine“</b> <b>Issue no. 43</b>  <b>Pages 139-147</b>	<b>2013</b>
--	--	-------------

## **EVOLUTION OF THE BLACK SEA SHORE IN THE DANUBE DELTA BIOSPHERE RESERVE AREA**

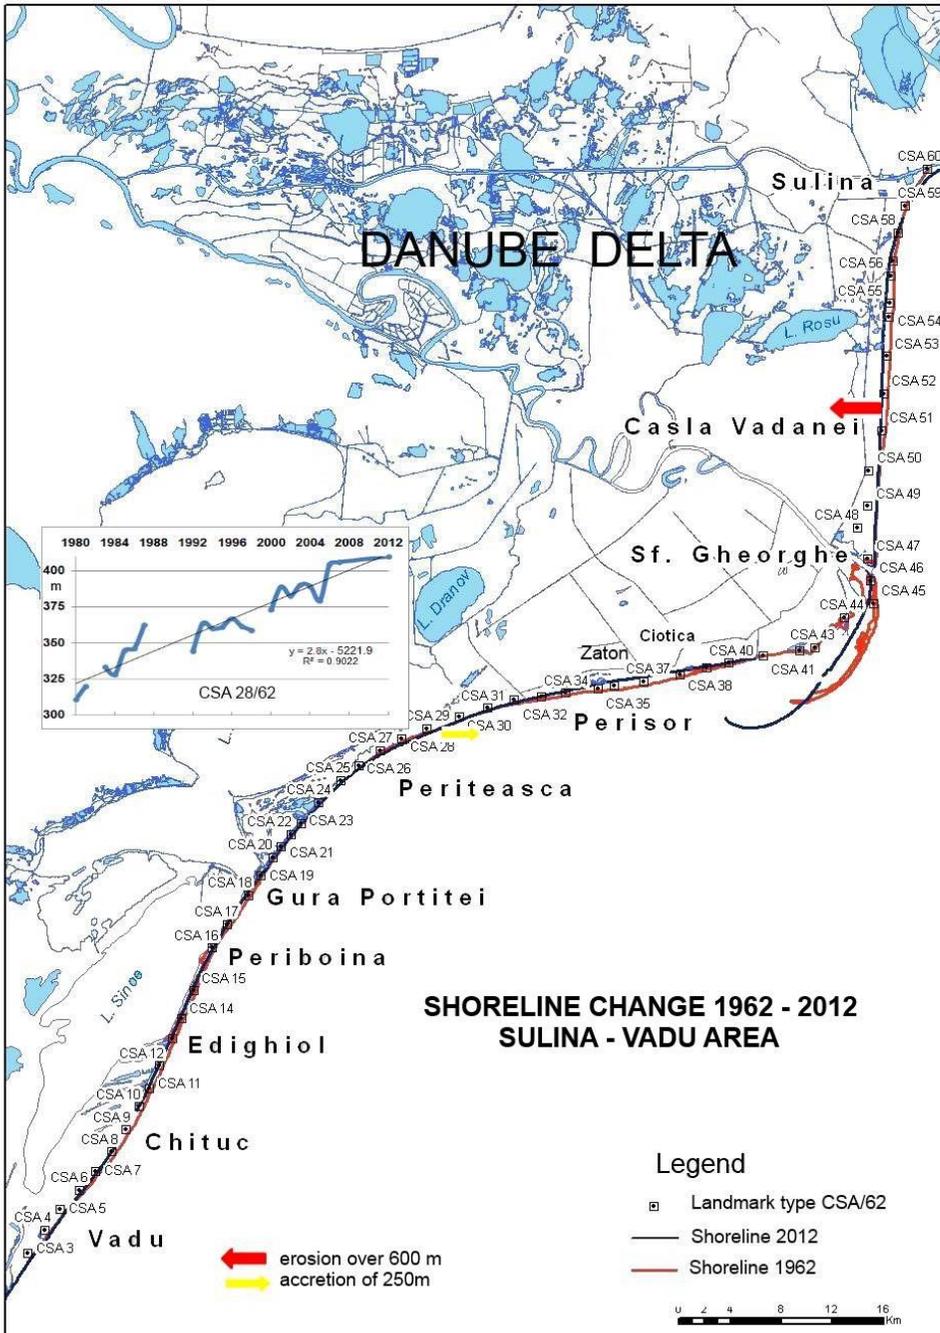
Fig. 1 - Diagram of the location of type CSA/62 landmarks

Due to the expansion of the erosion phenomenon in the Romanian coastal area, measures for the protection against erosion and for the improvement of the hydrotechnical planning of the Romanian shore have been taken since 1962. For this purpose, the first phase refers to the location of a landmark database in the coastal area. So, as a result of the study “Complex Development Plan of the Danube Delta“, the location of topographic landmarks from Gura Buhazului (Vadu) to the Sulina Channel was performed, on a length of approximately 140 km [1]. This network consists of 60 topographical concrete landmarks type CSA/62 (State Water Supplies) (Fig. 1).

When geomorphological measurements were performed in the 2012, only 16 of the 60 landmarks implemented in year 1962 were found (Fig. 1 and Table 1). Note that landmarks CSA 1/62 and CSA 2/62 were located in areas with special regime and we have no information about them.

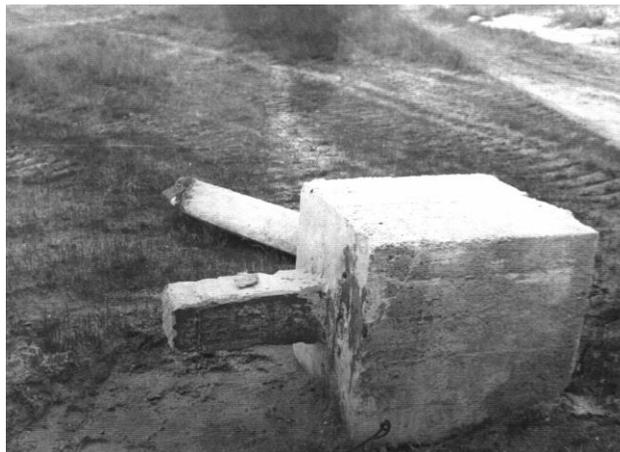
The *shore in Vadu*, about 5 km in length, is an accretion shoreline. In this sector are to be found 3 landmarks, CSA 6/62, CSA 5/62 and CSA 3/62). The landmark CSA 4/62 was destroyed in 1987, as a result of works carried-out in the area (Photo 1).

**Photo 1 - Landmark CSA 4/62 was destroyed in 1987**

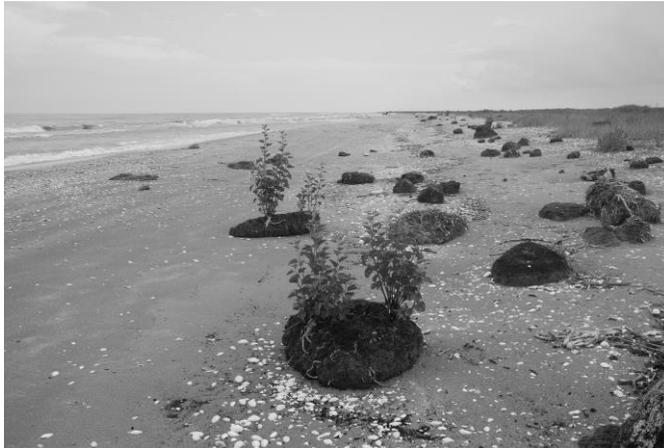
The *shore between North Gârla Îmпуțita - South Cășla Vădanei*, with a length of approx. 20 km, corresponding to the Roșu-Lumina depression, is characterized by a sedimentary budget deficit. The shore is more fragile, with heights from 0.5 m to 2 m and widths of 10-30 m, and most of reeds and set into the ground plaur go directly into the the sea and are washed by waves (Photo 2).

**Photo 2 - Reed rhizomes flooded by the sea (Cășla Vădanei, 2003)**

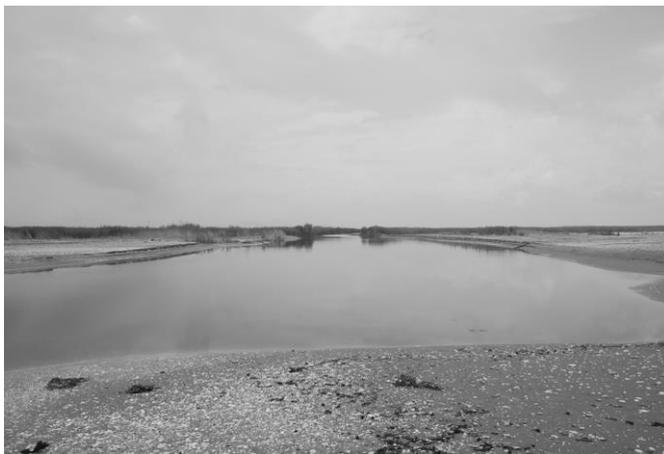
Frequently, in this section, during the spring-summer high water, seawater streams flow into the delta (Photo 3).

**Photo 3 - Lake - sea canal (Îmпуțita Sondei, 2008)**

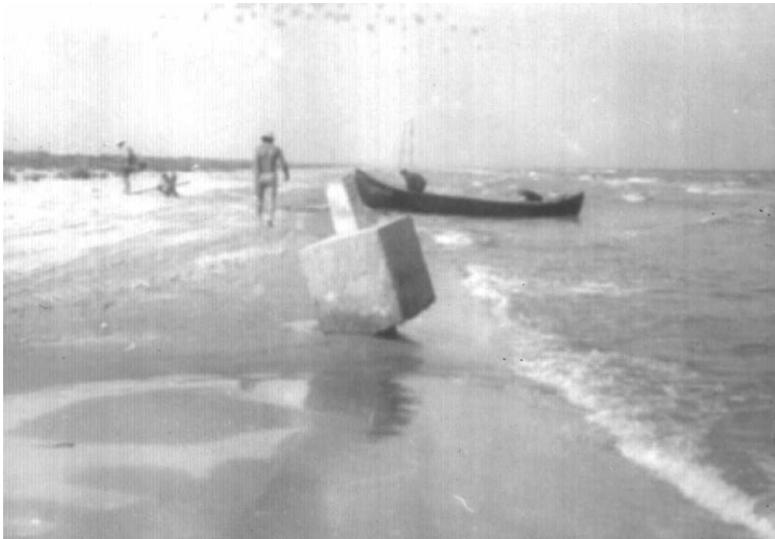
**Photo 4 - Landmark CSA 51/1962 on the shoreline in 1983**

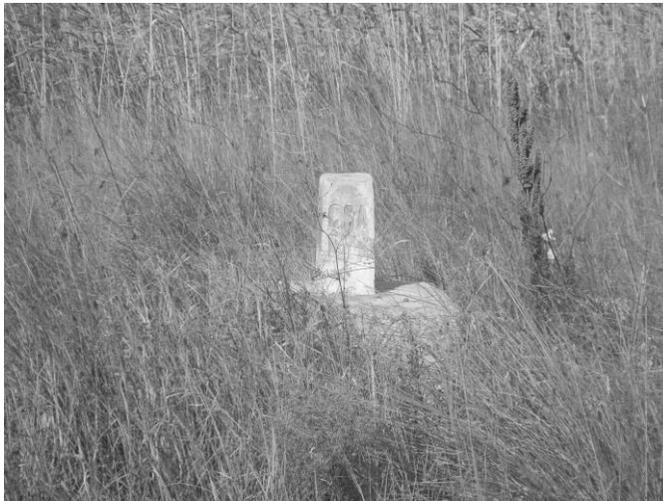
The *shore between North Portița - South Edighiol*, with a length of about 35 km, represents a complex beach with dune and depressions and active erosion of a coast. In this sector of beach, 18 type CSA/62 landmarks were initially placed, from CSA 23/62 to CSA 6/62, but in 2012 we have not found more than two landmarks, CSA 7/62 (Photo 5) and CSA 6/62.

**Photo 5 - Landmark 7/62 in 2012**

Landmarks on this shore were originally laid in 1962 at distances ranging between 40 m, CSA 22/62, and 200 m, CSA 10/62. The landmark CSA 22/62, set in 1962 at 40 m, CSA 20/1962 at 70 m, CSA11/62 at 60, CSA 9/64 at 150 m and CSA 8/62 at 160 m were very close to the front of the water in 1982 (CSA 22/62), 2012 (CSA20/62), 1978 (CSA 11/62), 1985 (CSA/9/62) and 1993 (CSA8/62). The greatest erosion occurred in the alignment of landmark CSA 10/62, with over 200 m, next to the landmarks CSA 7/62 - over 109 m - and the CSA 6/62 - over 42 m (see Table 1).
